NTSB National Transportation Safety Board

Office of Highway Safety

Girder Failure

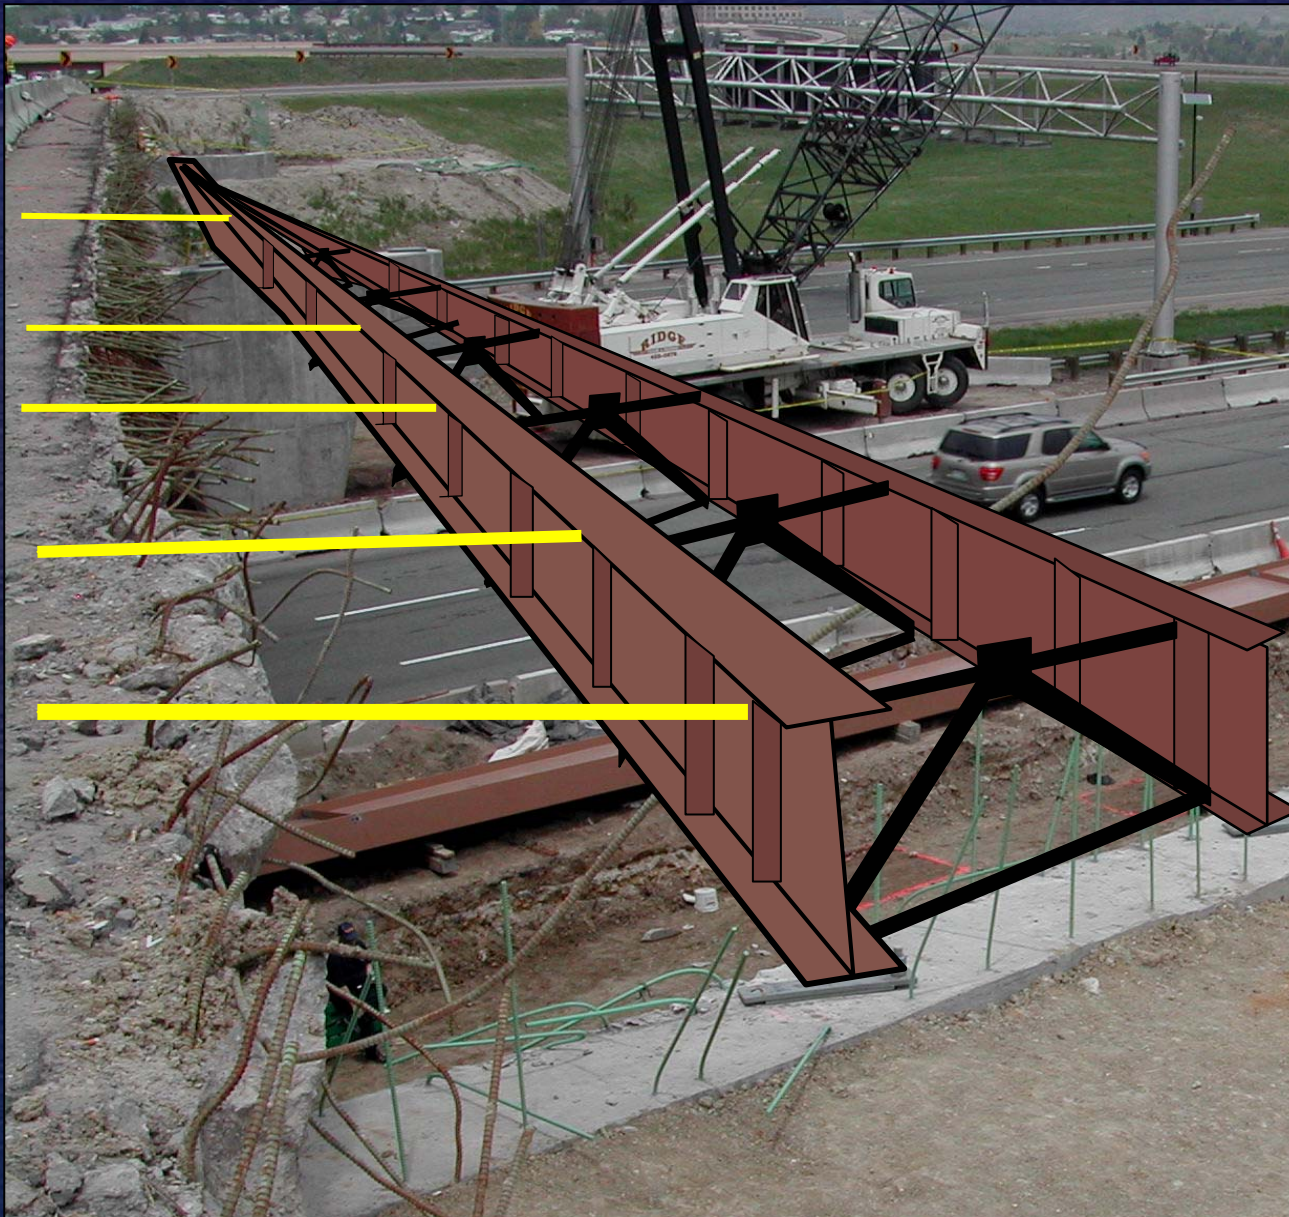
Install Two Girders

- Bracing plan lacked forethought
- Original intention to set two girders
- No contingency plan for securing ONLY a single girder

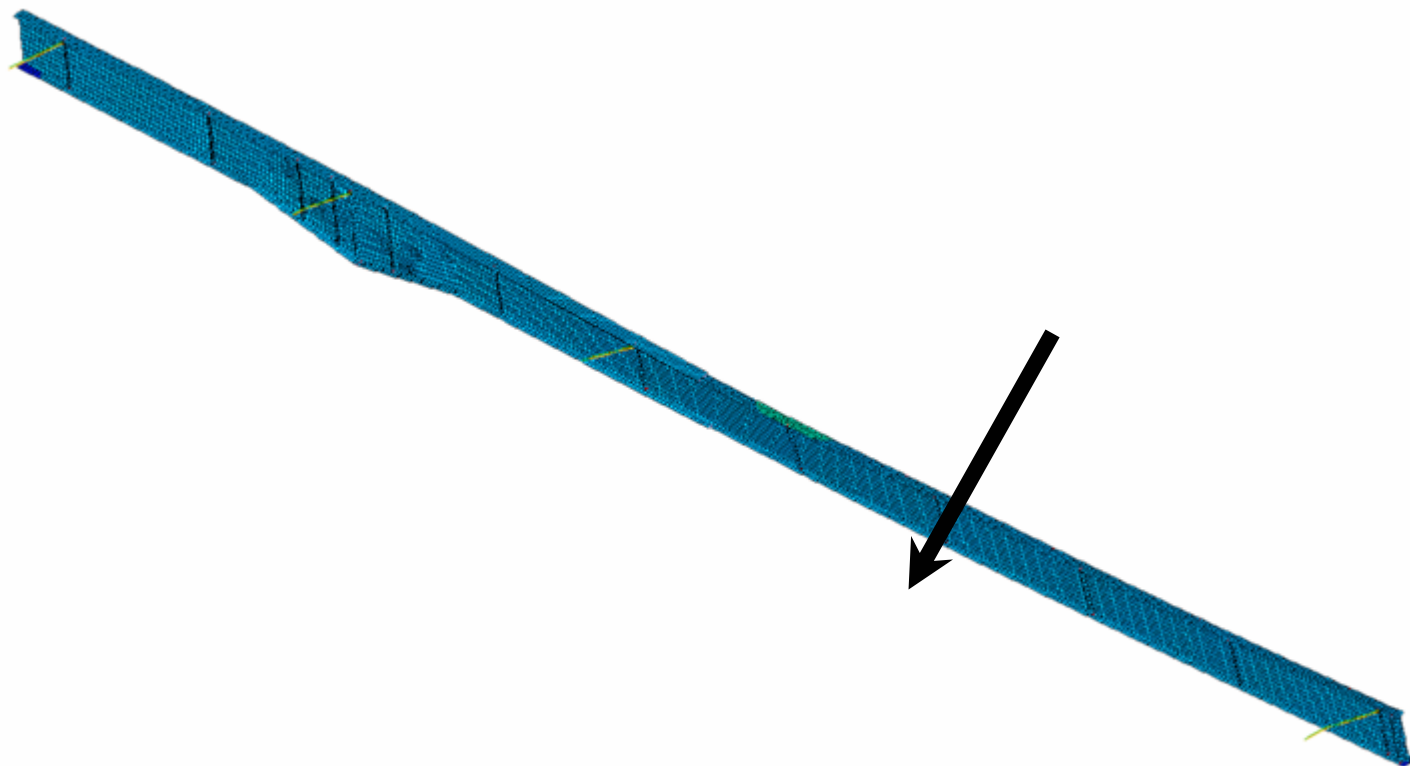
- FHWA Turner-Fairbank Highway Research Center
- Various combinations of braces were removed
- Brace 2 was the most critical to providing stability
